LE17-006SA -19401

July 21, 2017

**Re: Lacasse Park Grandstands
Structural Assessment
590 Lacasse Blvd.
Tecumseh, Ontario**

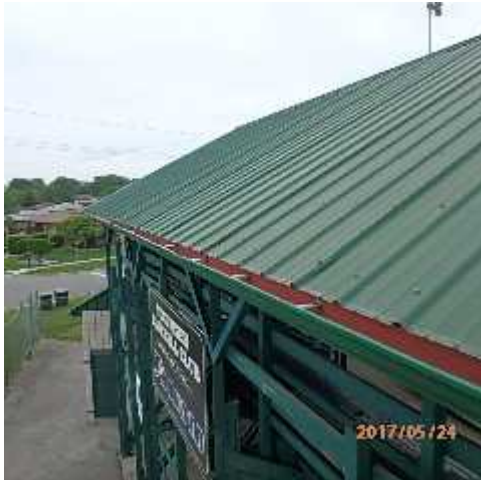
The corrugated steel roofing is generally in good condition with little or no corrosion (Photo 3). The top side exhibits some evidence of paint erosion (Photo 4). The bottom side has post applied paint that is severely peeling likely due to poor surface preparation (Photo 5 and 6). Colourmate screws used to secure the steel roofing to the wood purlins were observed to be loose and backing out in a few locations (Photo 7). Eave troughs are for the most part secure with some separation and leaking at seems (Photo 8).

Photo 3: Typical metal roof condition.

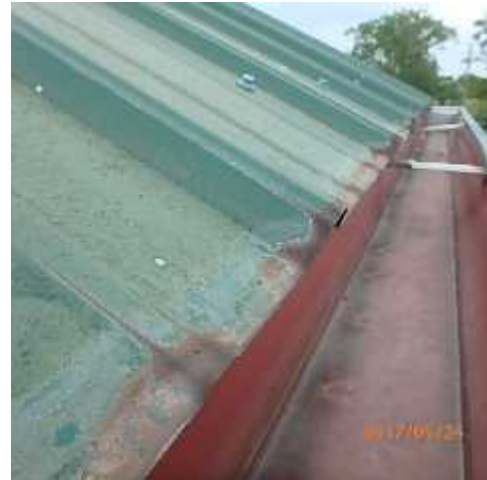
Photo 4: Paint erosion and minor corrosion.

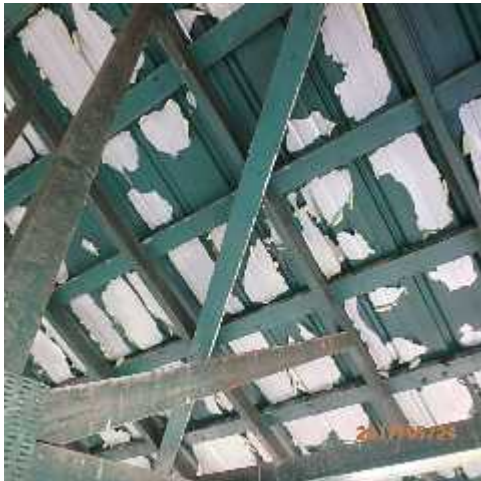
Photo 5: Peeling paint on underside of deck.

The steel roofing is general considered to be in good condition with little or no corrosion and only minor issues with loose fasteners. The underside of the roofing has a global issue with peeling paint that is unsightly. The roofing does not appear to be original to the structure.

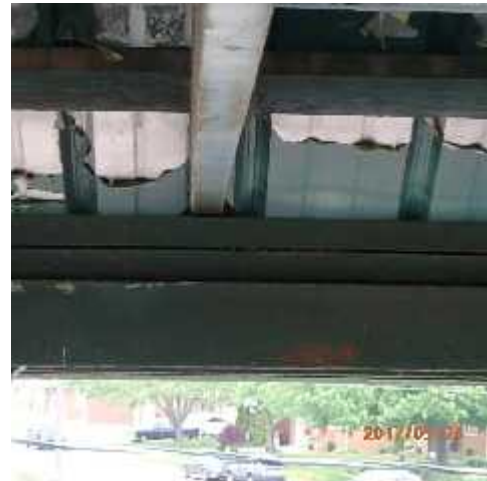
Photo 6: Peeling paint on underside of deck.

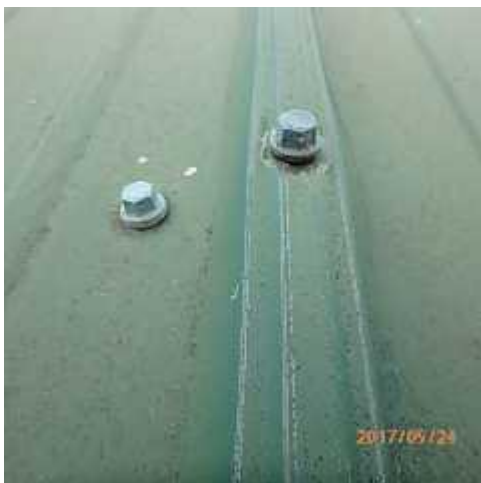
Photo 7: Loose metal roof screws.

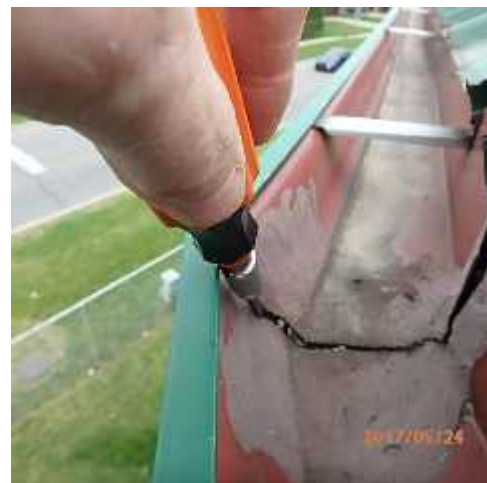
Photo 8: Eave trough separation.

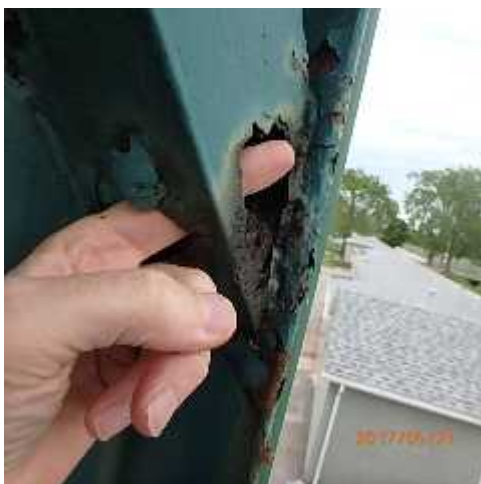
The steel frame is laterally stabilized via horizontal and vertical knee braces that are located in both directions at every post location (Photo 19 and 20). The intersection of the bracing has created a water trap which in numerous locations has led to advanced and severe corrosion of the steel elements (Photo 21, 22, 23 and 24).

Photo 21: Severe corrosion at water trap.

Steel framing is considered to be in poor to fair condition. There are areas of significant corrosion which will require repair. The existing detailing is problematic from drainage perspective and should be modified to prevent future accelerated deterioration. Steel will need to be cleaned and painted.

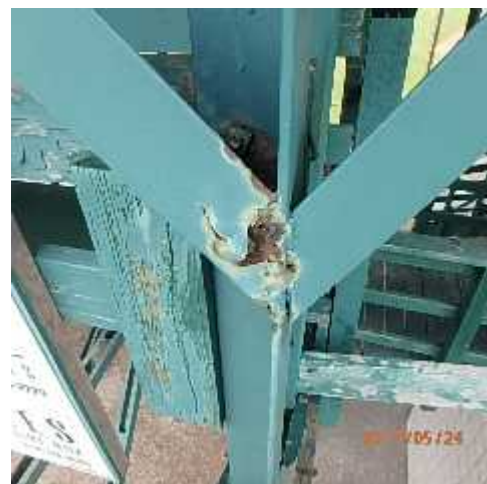
Photo 22: Knee brace corrosion.

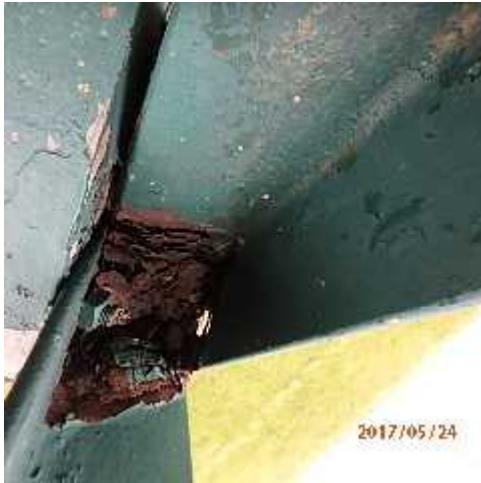
Photo 21: Steel corrosion at joint.

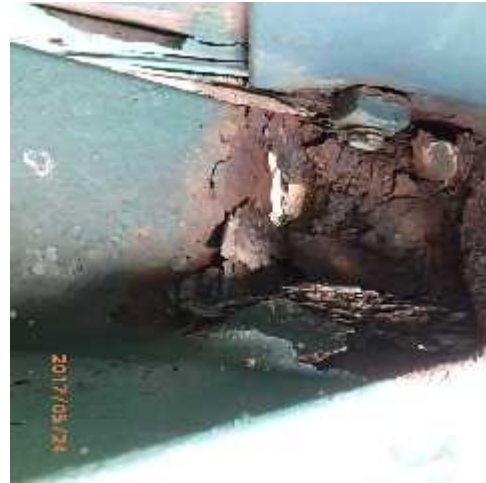
Photo 22: Typical steel corrosion.

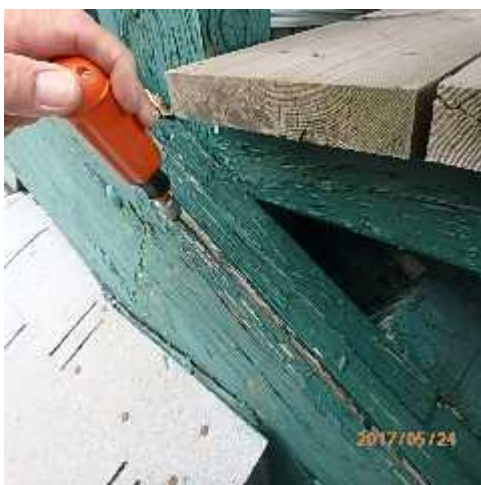
In general the wood elements, deck boards as well as stringers, posts and bracing, are all at some level of deterioration which ranges from peeling paint to rot resulting in loss of section (Photo 29, 30, 31, 32, 33, 34, 35 and 36).

Photo 29: Typical wood deterioration.

Wood framing is generally in poor condition. Although there have bee ongoing repairs and maintenance to replace and reinforce rotten and broken seat boards, foot boards and framing elements on an individual basis, a full assessment of the framing and wood condition should be conducted to determine areas requiring repair. It is estimated that up to 30% of the wood elements will require replacement. The wood structure is also in need of repainting.

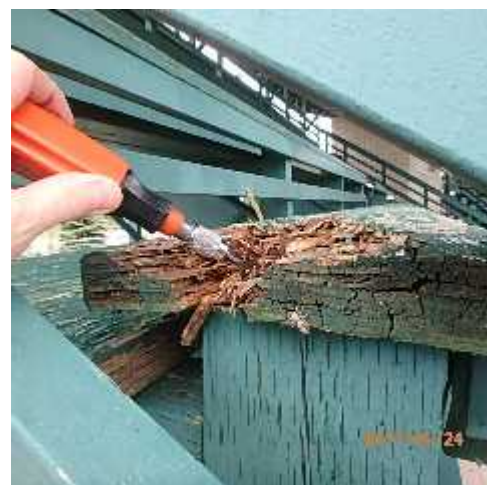
Photo 30: Wood rot at seat board.

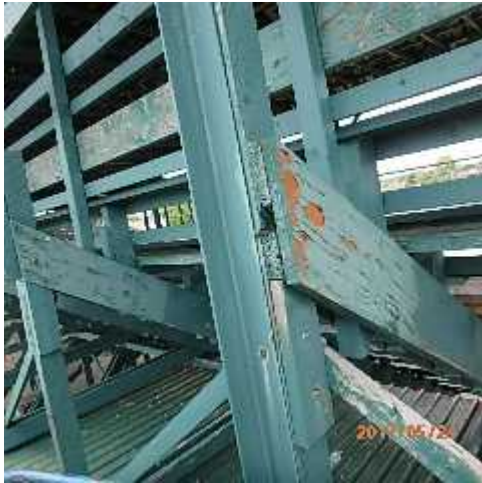
Photo 31: Wood rot at diagonal bracing.

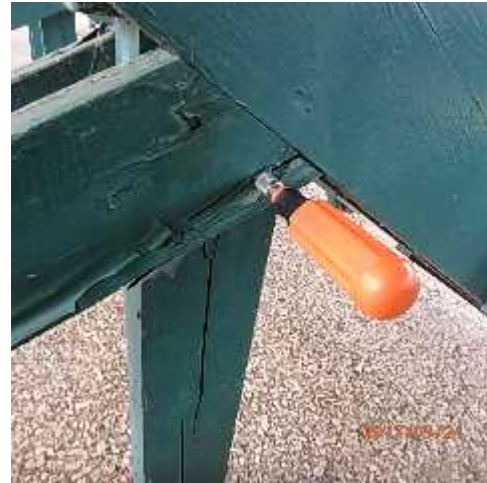
Photo 32: Wood rot at horizontal tie.

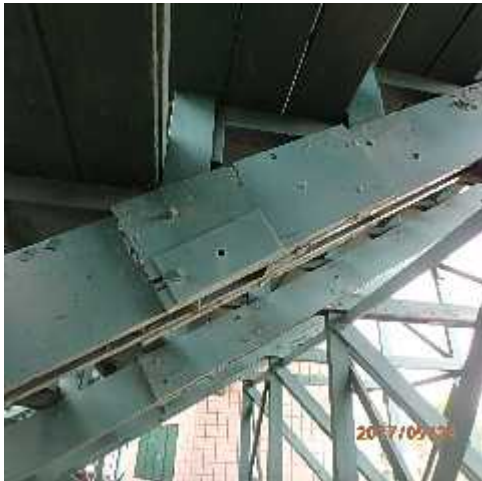
Photo 33: Structurally augmented stringer.

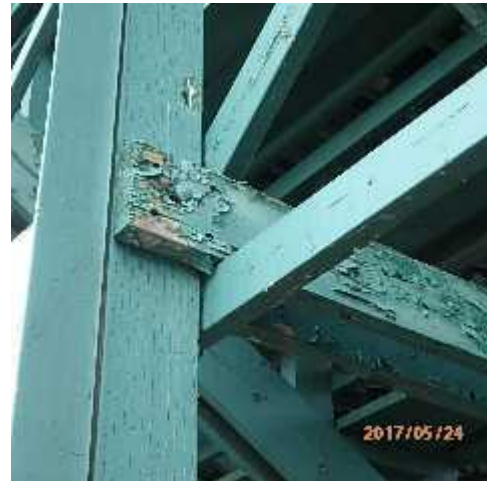
Photo 34: Typical paint and wood deterioration.

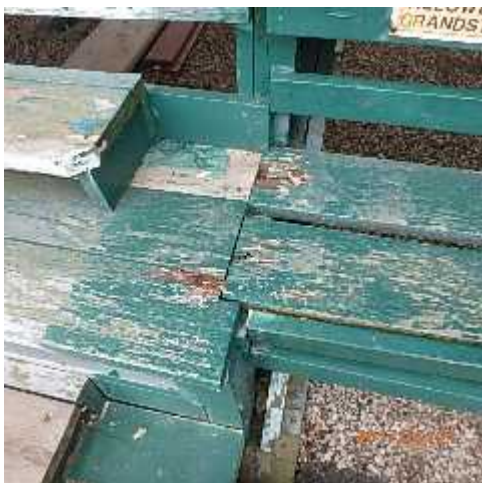
Photo 35: Wood rot at floor boards.

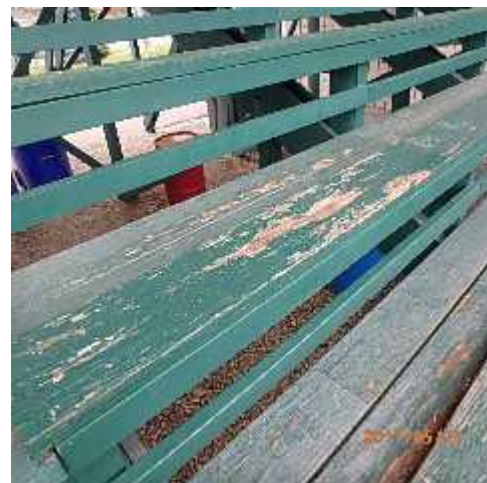
Photo 36: Deterioration of seat boards.

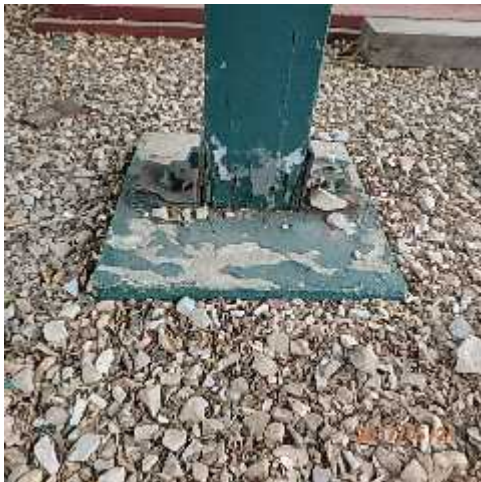
Wood posts that support the bleachers as well as parts of the roof structure along with the front edge of the stringers bear on concrete footings (Photos 37 and 38). The footings are of an unknown depth, are flush with or below grade and in some locations appear to have shifted (Photo 39 and 40).

Photo 39: Typical post on footing.

The wood post and stringers are in very poor condition especially where they are near grade. The concrete footings, which are of indeterminate construction, are not high enough to provide separation from grade as required by the current building code. Additionally the wood material is not isolated from the concrete allowing for a continuous absorption of moisture from the damp concrete. Extensive modification to the grading and footings along with repair of post and stringers is recommended.

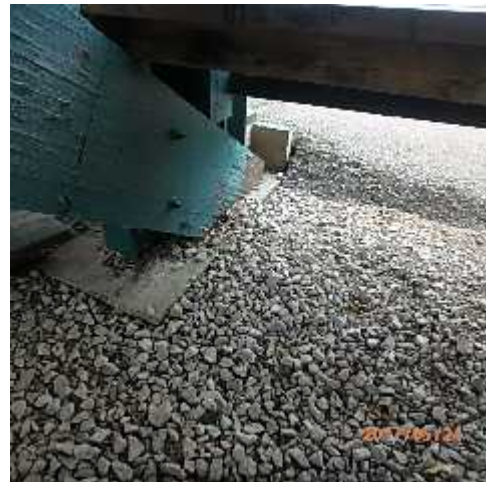
Photo 40: Typical stringer base.

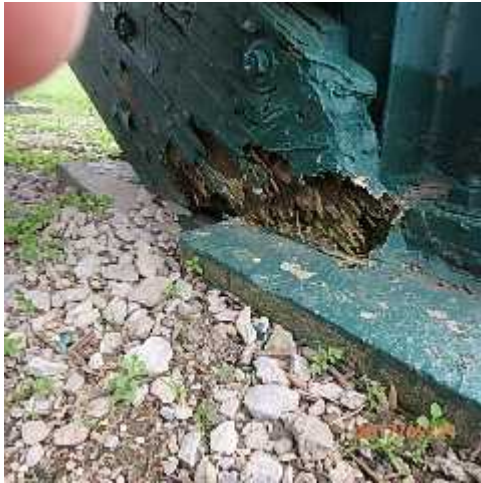
Column and stringers and post bases in numerous locations are rotting and steel anchors are in an advanced state of corrosion (Photo 41, 42, 43 and 44). Wood posts were also noted to have large vertical splits in a number of locations (Photo 45 and 46).

Photo 41: Rotted stringer base.

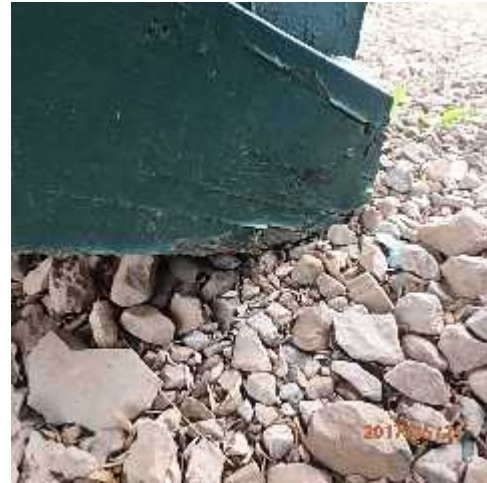
Photo 42: Stringer on buried footing.

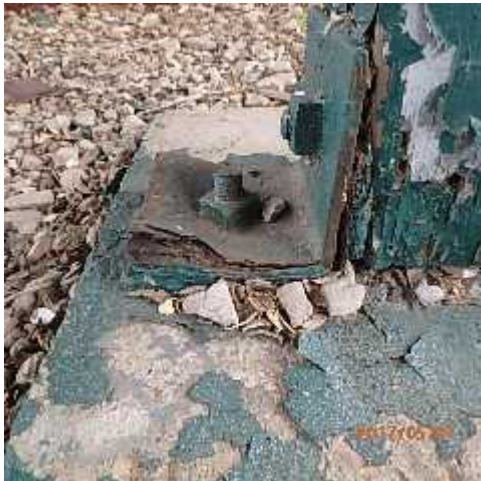
Photo 43: Corrosion of anchor to footing.

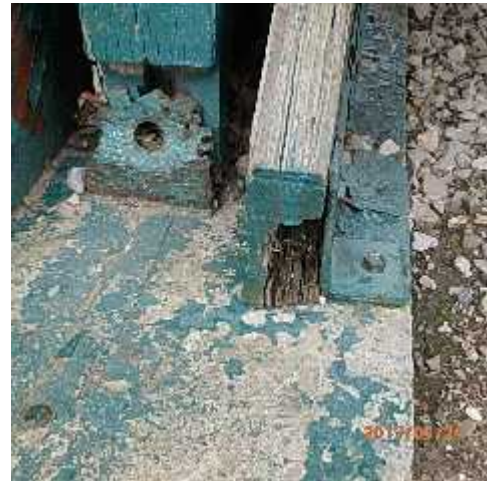
Photo 44: deteriorated post and stringer.

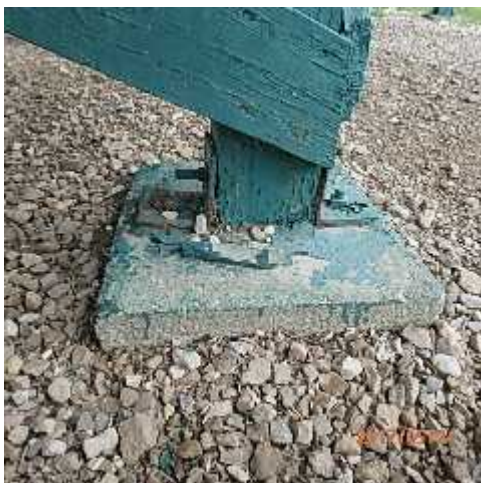
Photo 45: Typical post base deterioration.

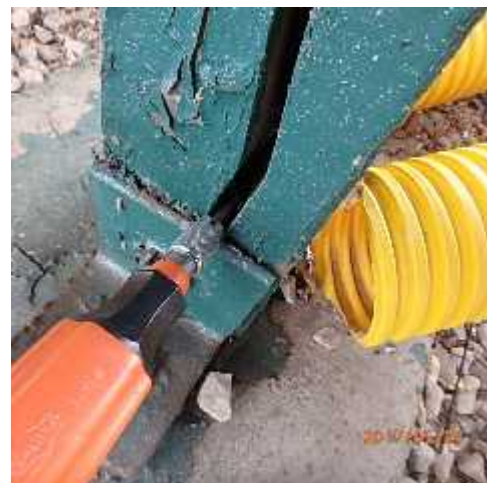
Photo 46: Split post at base.

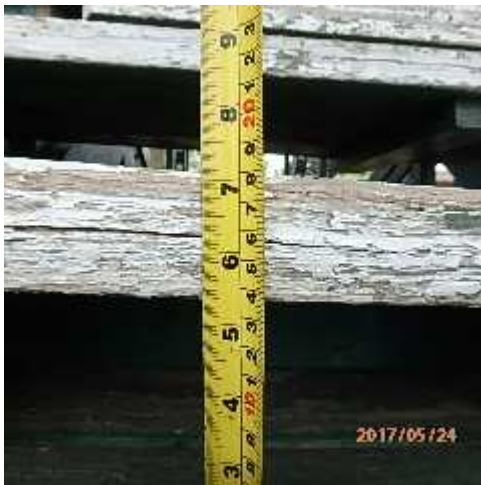
At the Lacasse Grandstand there were two significant areas of non compliance that were noted. The first is that the risers on stairs are inconsistent within a given flight. Riser heights varied between 7" to 9-1/2" (Photo 47 and 48). In addition it was noted that the gap between the seat board and the floor board exceeded the maximum 4" allowed by the OBC (Photo 49 and 50).

Photo 47: Measured riser height of 7".

The existing grandstand does not comply with some aspects of the current OBC. These items should be addressed when the next phase of repair is undertaken.

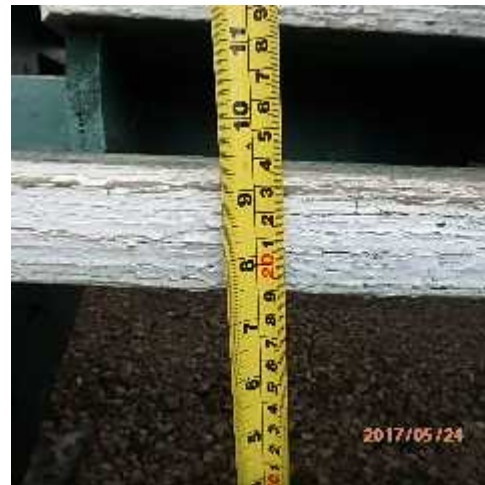
Photo 48: Measured riser height of 9-1/2" in same flight.

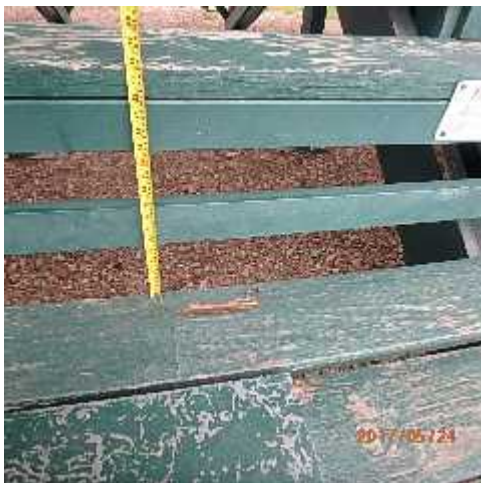
Photo 49: Typical gap between floor board and seat.

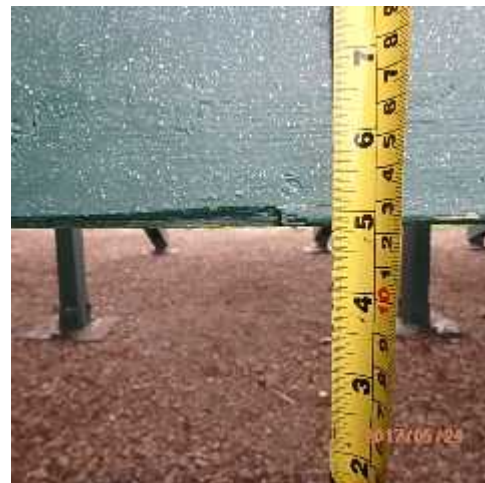
Photo 50: Maximum gap allowed is 4".

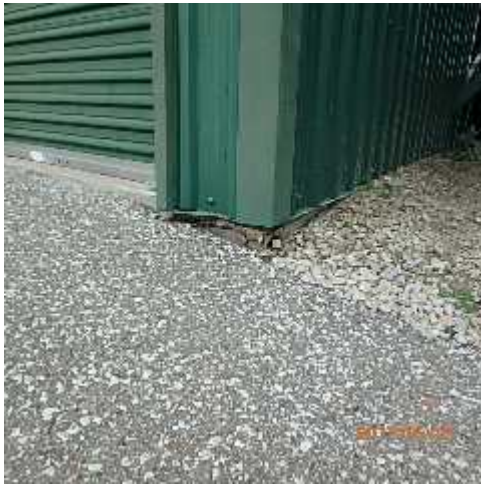
There is a storage shed that is supported on a wood footing on grade and has very poor roofing detailing at penetrations (Photo 52 and 53).

Photo 51: Storage shed on wood footing.

The storage shed that is built into the grandstand structure is poorly detailed with respect to foundation and roof penetrations.

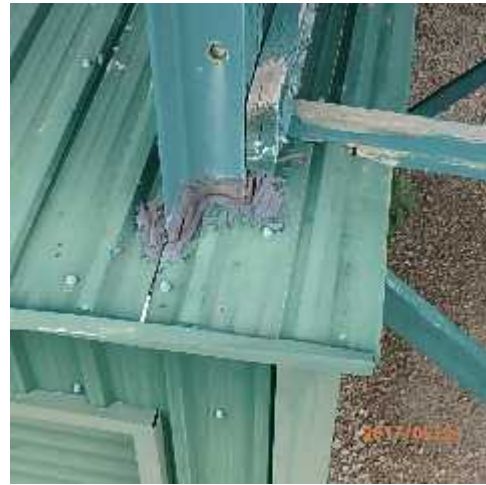
Photo 52: Poor waterproofing detail.

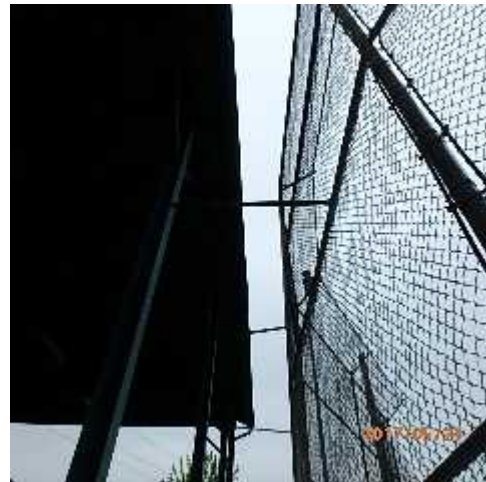
It was also noted that the backstop screen for the baseball diamond is braced back to the grandstand structure (Photo 54).

Photo 54: Backstop connection to grandstand.

The existing backstop for the baseball diamond is braced back to the grandstand structure. If modifications are made to the grandstand it is likely that the backstop will require additional support or replacement.
