TREE ASSESSMENT REPORT

12433 DILLON DRIVE
TECUMSEH, ONTARIO

NOVEMBER, 2019

RKLA PROJECT NO. 19-231

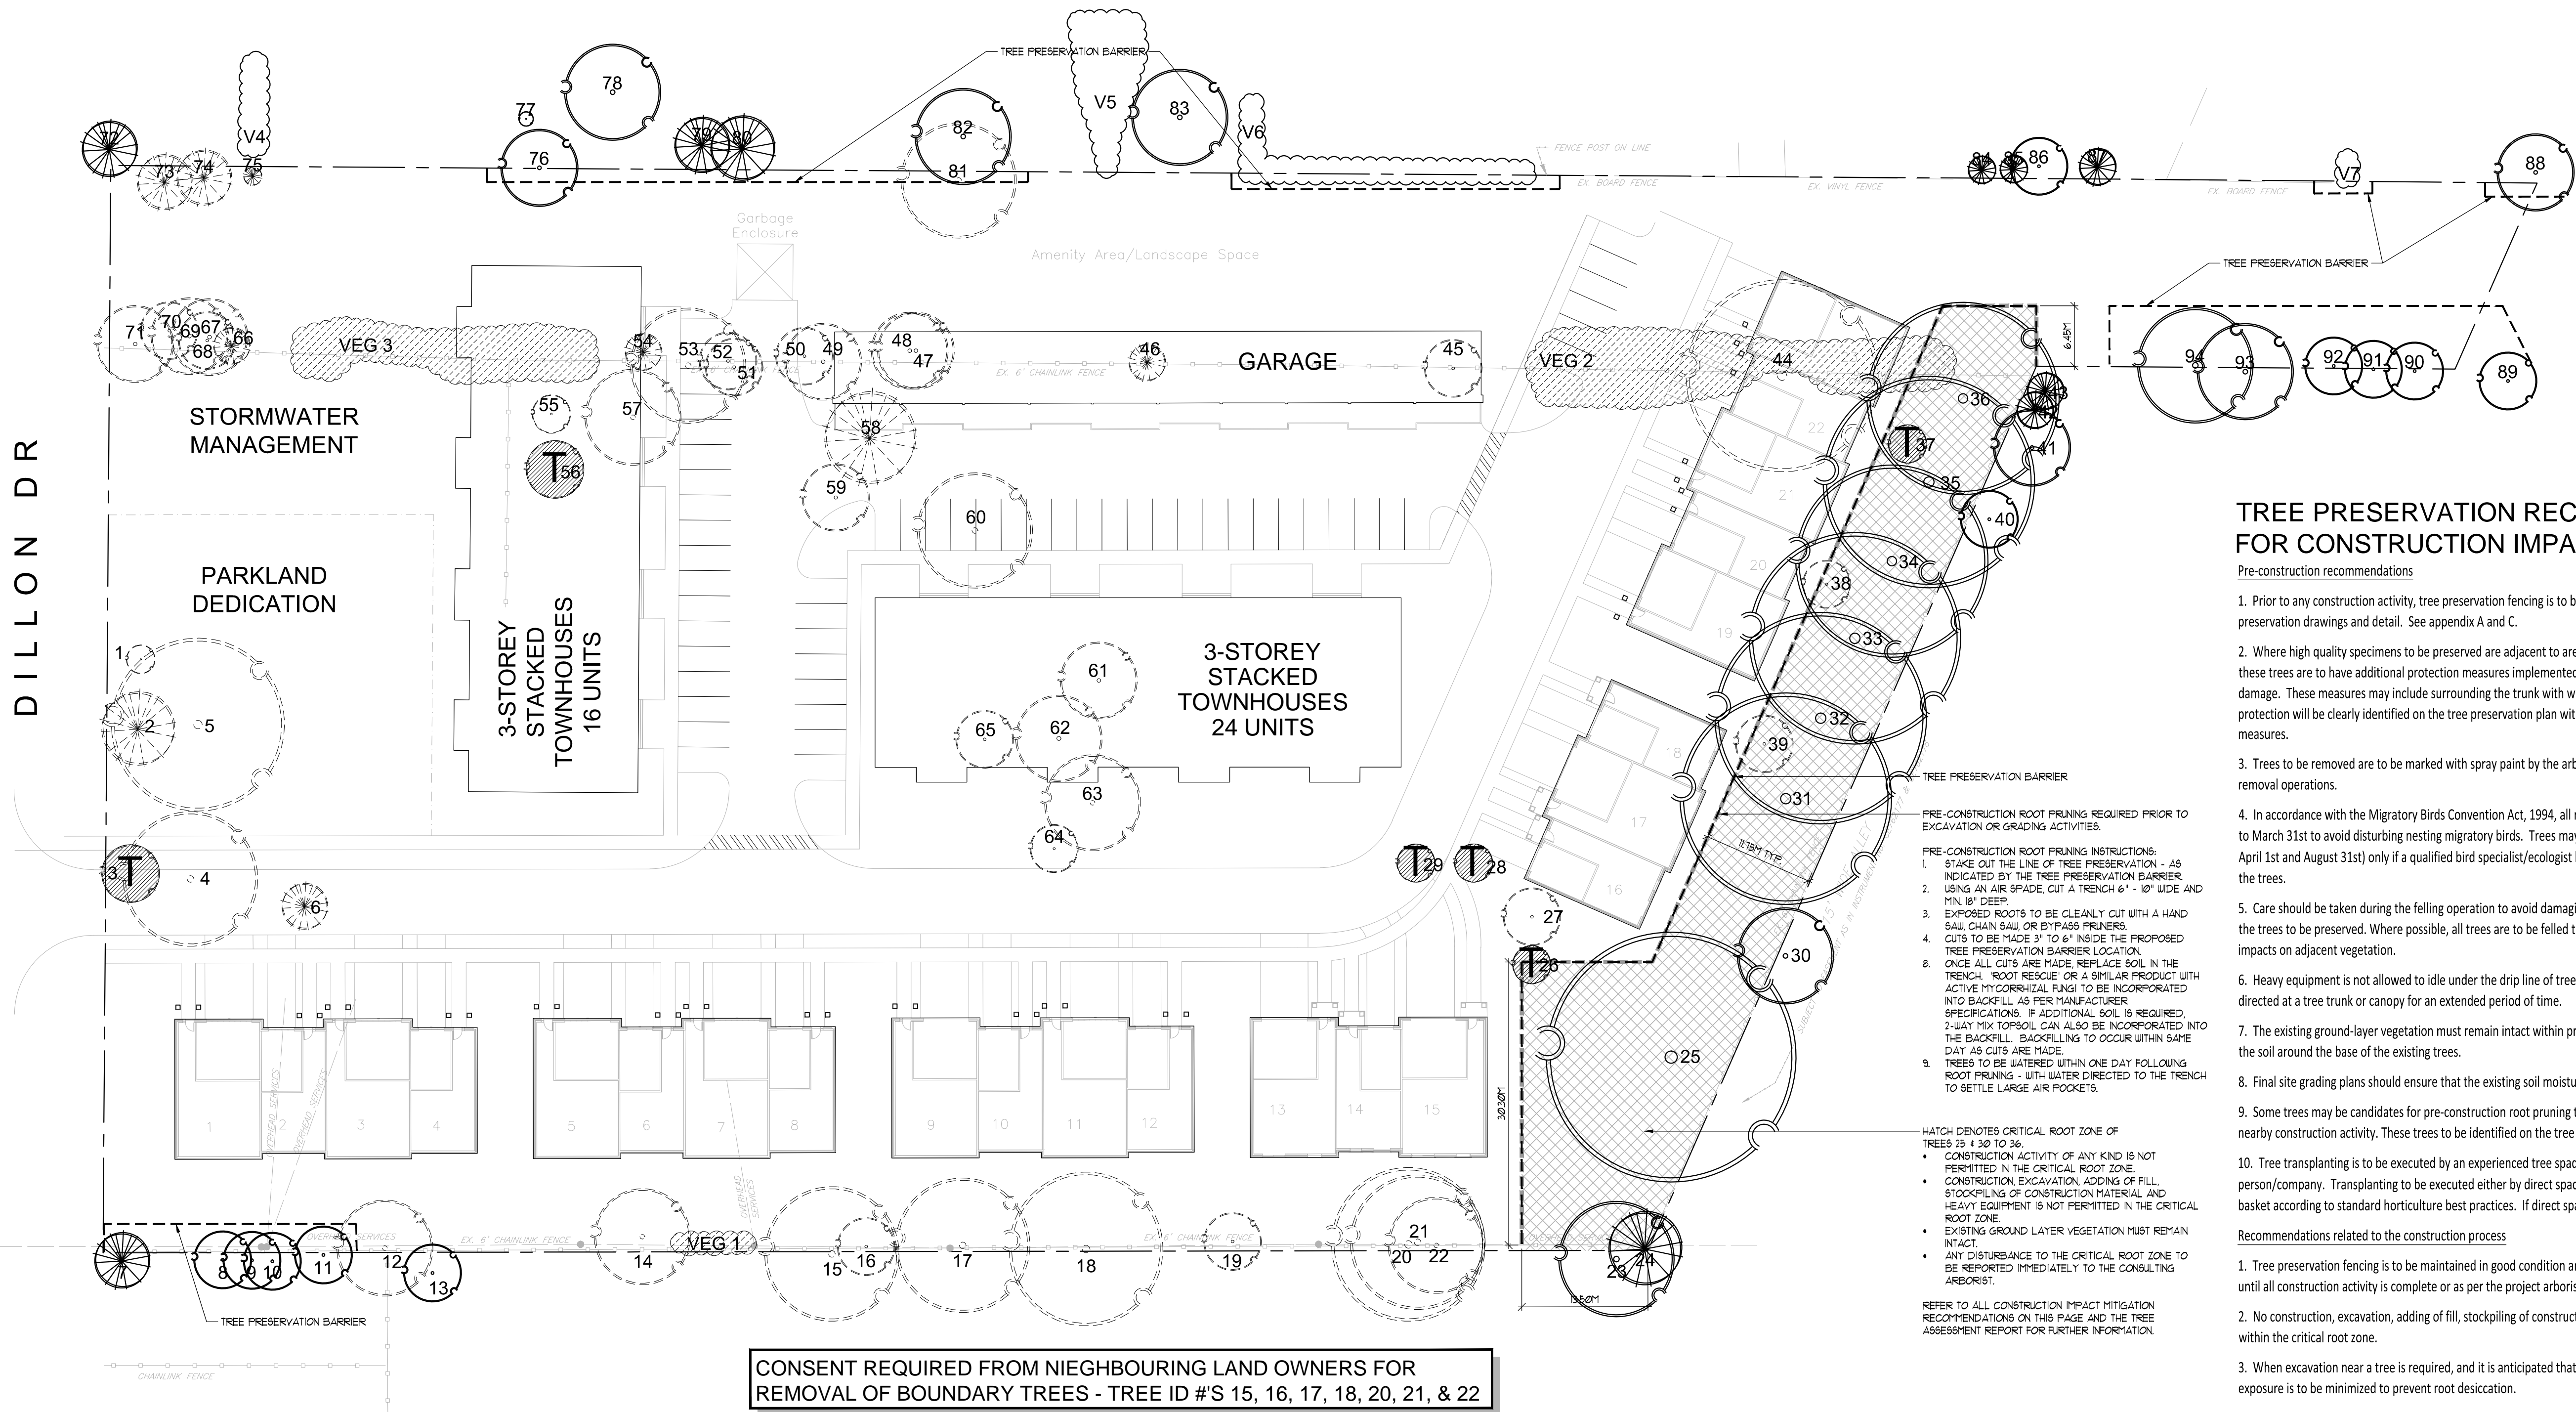
TREE PRESERVATION PLAN

CONSENT REQUIRED FROM NIEGHBOURING LAND OWNERS FOR
REMOVAL OF BOUNDARY TREES - TREE ID #S 15, 16, 17, 18, 20, 21, & 22

- KENTUCKY COFFEE TREES TO BE TRANSPLANTED OFF SITE OR ON SITE UNDER DIRECTION OF PROJECT MANAGER. PROPOSED NEW LOCATION OF TRANSPLANTED KENTUCKY COFFEE TREE WITH TREE PRESERVATION BARRIER (TO BE DETERMINED).
- EXISTING DECIDUOUS TREES TO REMAIN.
- EXISTING DECIDUOUS TREES TO BE REMOVED.
- EXISTING CONIFEROUS TREES TO REMAIN.
- EXISTING CONIFEROUS TREES TO BE REMOVED.
- EXISTING VEGETATION UNITS TO REMAIN.
- EXISTING VEGETATION UNITS TO BE REMOVED.
- TREE PROTECTION BARRIER.
- ROOT PRUNING REQUIRED PRIOR TO CONSTRUCTION.
